PROJECT TITLE: REPAIR WORKS TO FIRE DAMAGED ELEMENTS IN AN OFFICE BUILDING, PETALING JAYA.

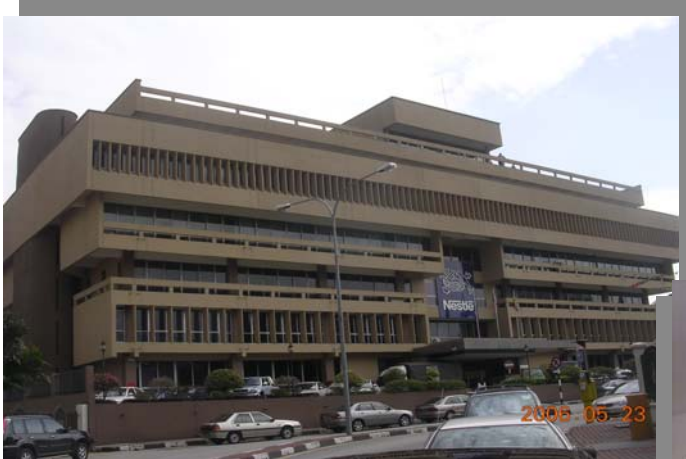
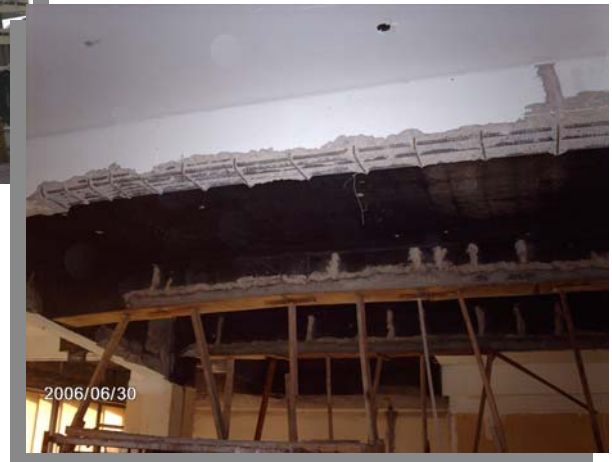
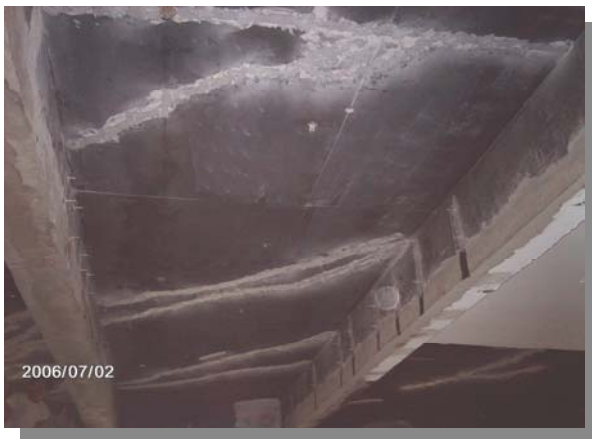
Cracks and spalled concrete were observed on the underside of the beams and slabs after the fire.

The physical fire damage assessment and detailed testing to fire damaged RC members was conducted to ensure the sustained structural integrity and stability as well as the future durability and serviceability of the building. Concrete repair work was required for most fire damaged beams and slabs to reinstate the structural elements.
