PROJECT TITLE: REHABILITATION AND REPAIR WORKS TO BRIDGE NO.1 AT KM 1.000 IN PERAI

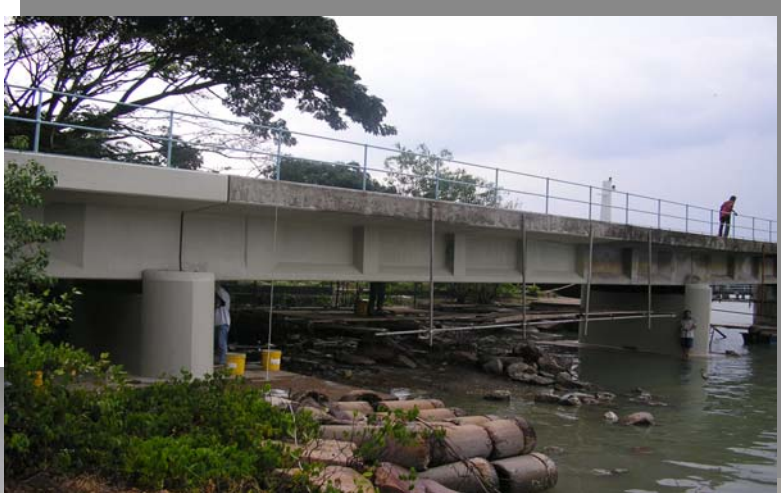
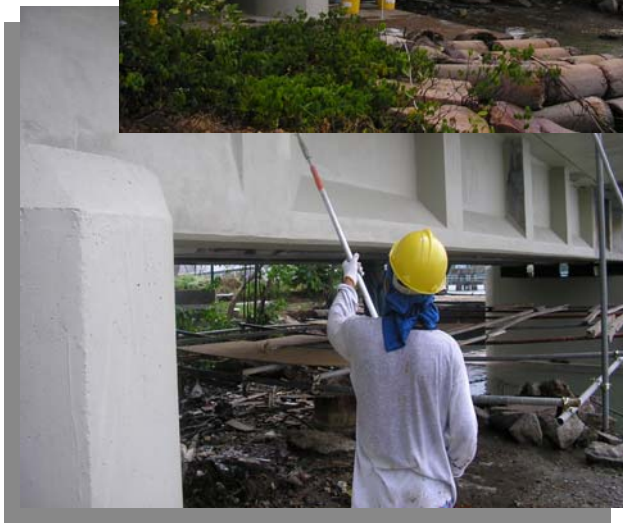
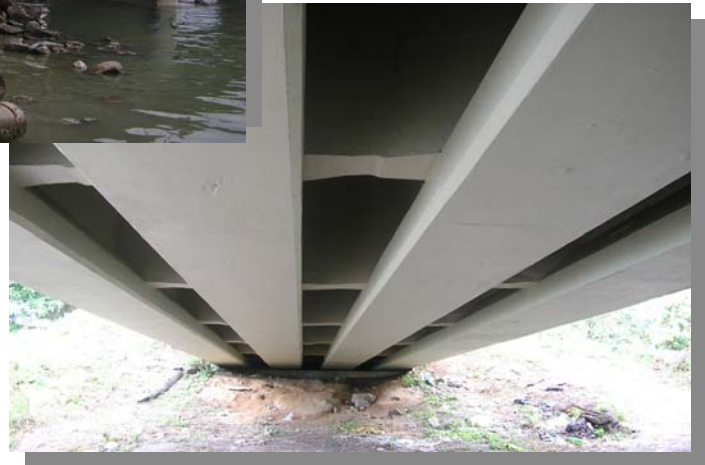
Cracks were formed in structural members and spalling and defective concrete were found on the concrete structures due to severe corrosion of the steel reinforcement.

Formwork grouting and patching were the major scope of works to repair the defective concrete. Strengthening to some of the beams was required to reinstate the original capacity of the beams. Protective coating was applied on the exposed concrete surface.
