PROJECT TITLE: REMEDIAL WORKS AT A PETROCHEMICAL JETTY AT BAGAN LUAR, BUTTERWORTH, PULAU PINANG

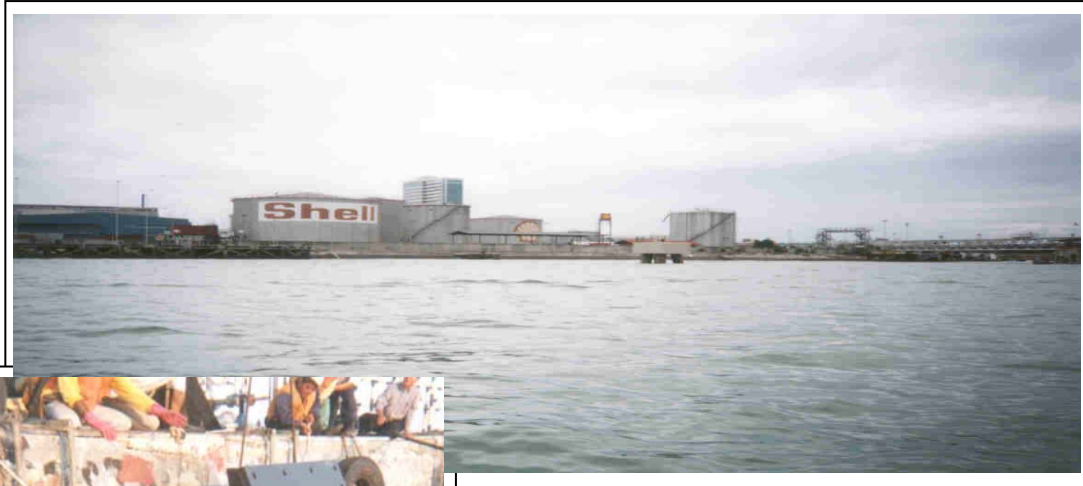
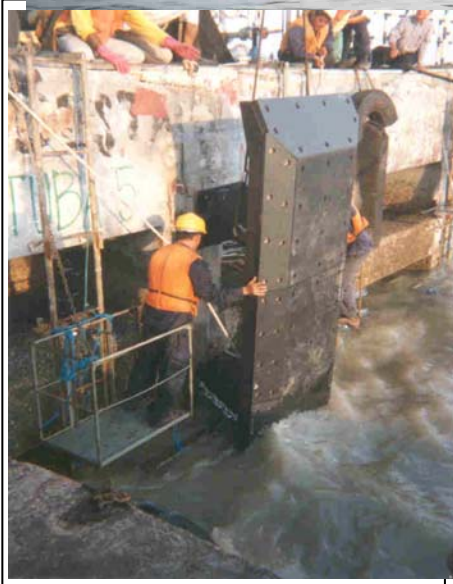
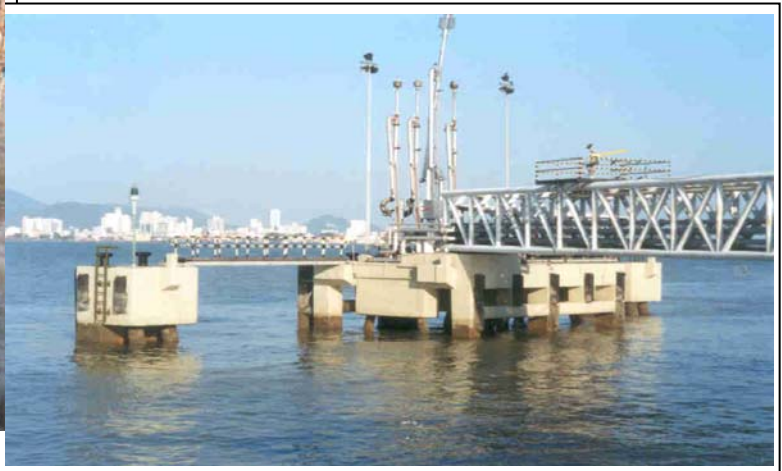
Cracks were formed in structural members and spalling and defective concrete were found on the slabs, beams, sides of the breasting dolphins and mooring dolphins. Severe corrosion occurred at the reinforcement bars. Thus, the expansion of corroded rebar caused the concrete to spall and crack.

Epoxy injection, formwork grouting and patching were the major scope of works to repair the defective concrete. Protective coating with anti carbonation paint was applied on the exposed concrete surface to prevent further corrosion.
