PROJECT TITLE: RECTIFICATION WORKS OF PASSENGER JETTY AT MERSING

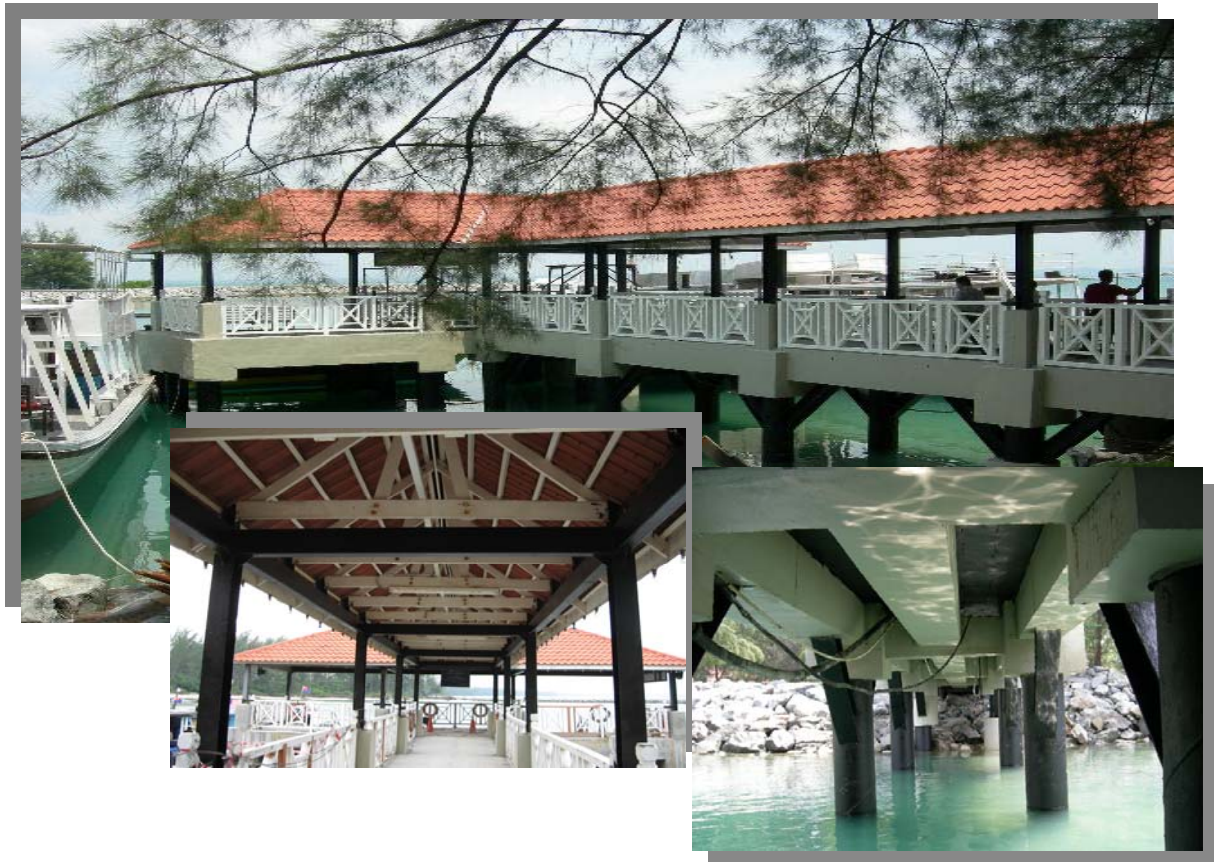
Chloride induced corrosion causing spalling concrete and cracks were the main problems at the Tg. Leman and Pulau Sibul Resort jetties.

The RC beams were enlarged and steel beams were jacketed using formwork grouting method. Spalling concrete at the soffit of deck slab was repaired using pressure grouting. Protective coating was applied to the under deck RC structures and the steelwork to enhance durability. Extra care was taken not to pollute the surroundings.
