PROJECT TITLE: REPAIR WORKS TO REINFORCED CONCRETE SILOS 1-6 FOR FLOUR AND FEED MILL PLANT

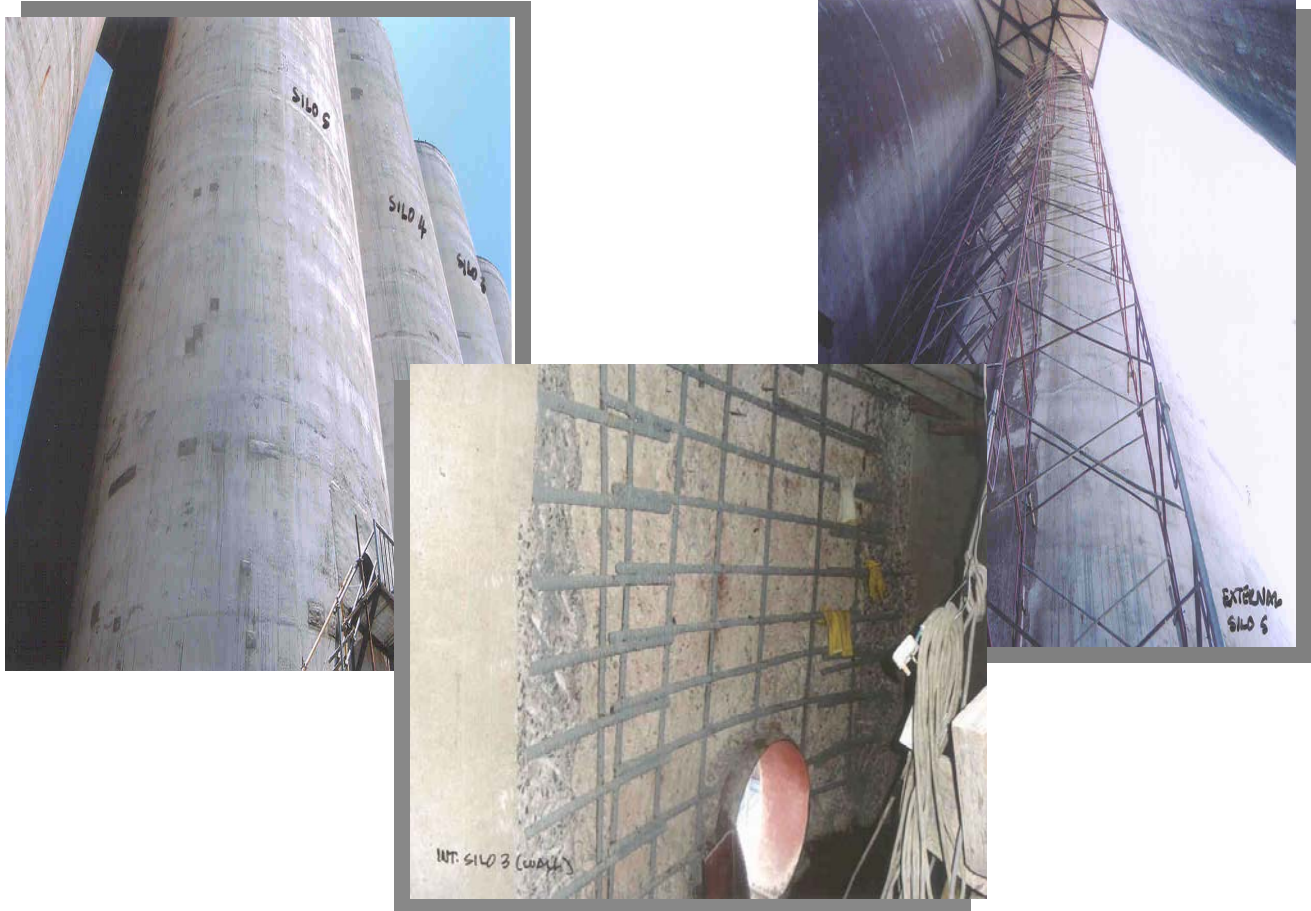
Cracks, spalling and defective concrete were found on the soffit of RC roof slab, basement slab, internal surfaces of the stairwell and RC silos due to severe corrosion of the steel reinforcement.

Crack repair, formwork grouting and patching were the major scope of works to repair the defective concrete. The existing waterproofing system to the RC roof slab was removed and replaced. Cleaning works to the external concrete surface of the stairwell and silos were also carried out.
